Director's Order

FINAL REPORT

**1376 County Road 2, Escott, ON
Phase 2 Environmental Site Assessment
Project No. 121-21627-00
Photo List**

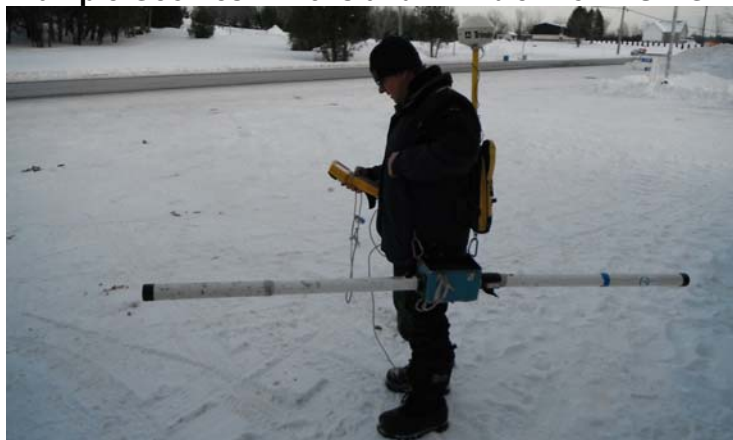
Changes in the sub surface conditions can be mapped with this instrument. Bedrock typically will have a low apparent conductivity near 0 mS/m while wet sand and silt may have higher values of 10 to 20 mS/m. Clay or contamination may have conductivities in the order of 20 to 100 mS/m. Although not sensitive to smaller pieces of metal, large objects such as barrels, piping or cables will result in a large amplitude response well in excess of that expected from contamination plumes.

The apparent conductivity is proportional to the out of phase measurement. Over natural conductivities, the In-phase measurement does not change; however, In-Phase will be sensitive to significant metal.

Example Geonics EM-31s and Trimble Pro XRS DGPS

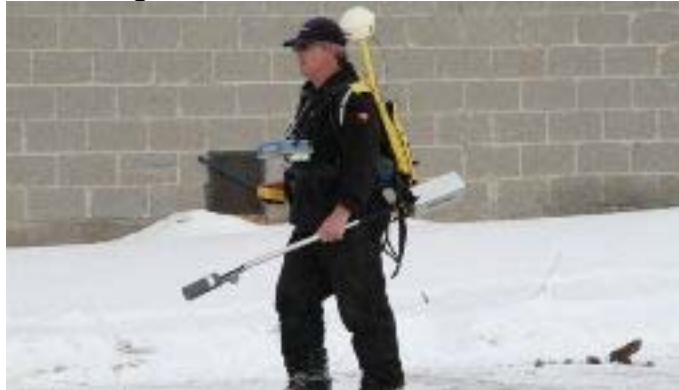
The Scintrex Smartmag is an optically pumped cesium vapor magnetometer that can record magnetic measurements at a rate of 10 readings per second with a 0.1 nT resolution. Due to the compact sensor cavity, the cesium vapor has an advantage over other digital

Over natural soils and rock conditions, the magnetic field would only be expected to change slowly (0's of nT) over a site such as the one surveyed. Ferrous metal such as found in barrels, culverts, manhole covers and signs would change the local magnetic field in the vicinity by up to 10,000 nT. The shape of the magnetic anomaly combined with the surface area can be used to imply an objects size and depth.

Example -Scintrex Smart Mag Total Magnetic Field Magnetometer and Trimble Pro XRS DGPS

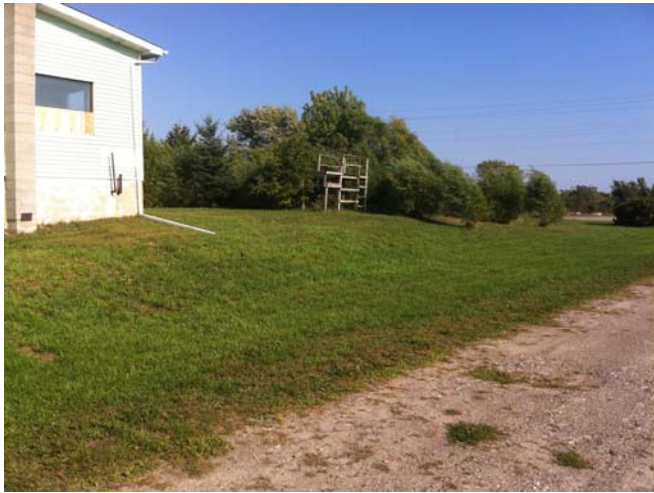
Viewing South from Central Lane Way Corner

Both the magnetometer and EM31 detect the septic tank as well as other visible features, including two wells, fencing, signs and a culvert.

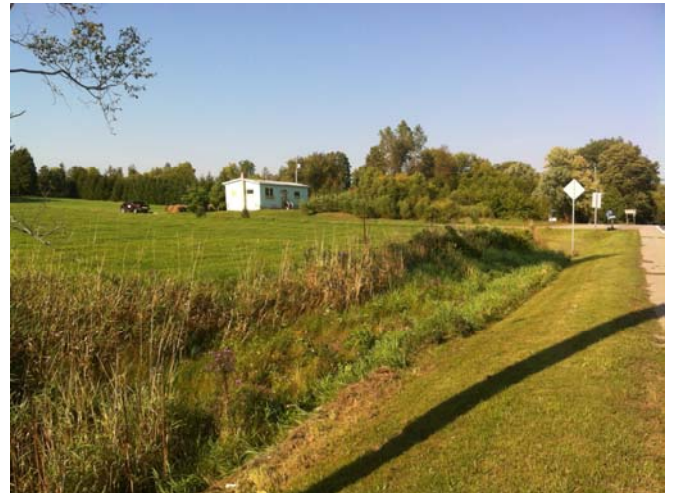
Viewing North East from South West

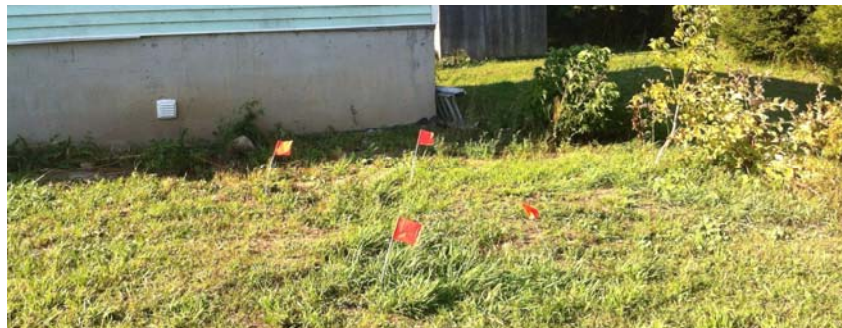
Flags Indicate Approximate Location of Septic Tank

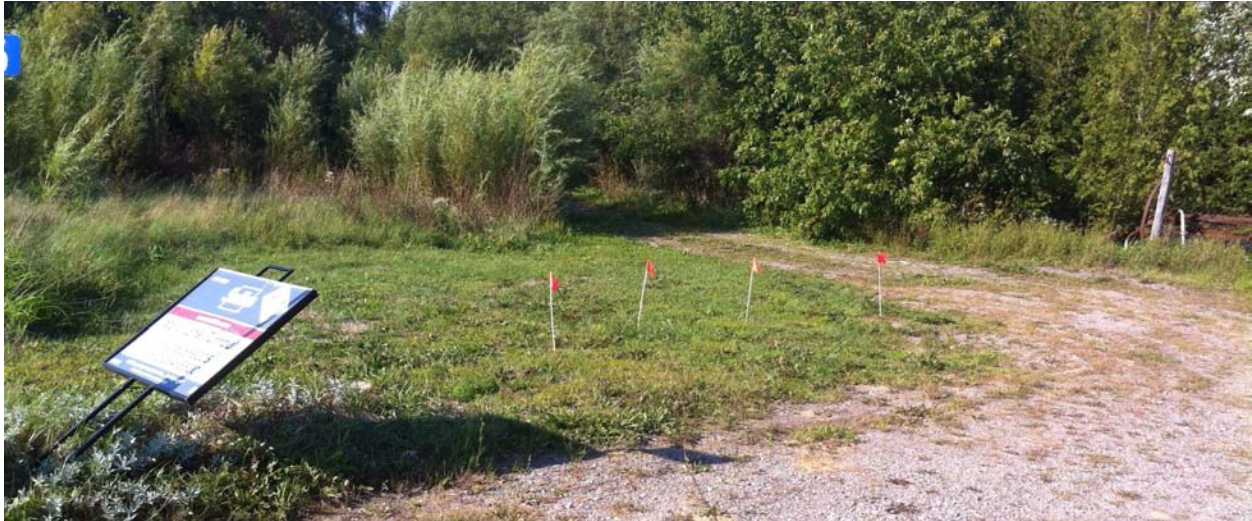
One dominant magnetic anomaly is present just east of the **For Sale** sign between the two lane ways. The magnetic field is elevated by over 3000 nT and it has a surface area of over 5m x 1.5m. Careful inspection of the EM31 data shows that there is a coincident decrease in apparent conductivity of 7 mS/m over this area. There is buried metal at this location with the potential to be due to an underground storage tank.

Flags Indicate Location of Large Magnetic Anomaly

There is an additional magnetic and electromagnetic anomaly present within the old lane way approximately 7 meters north of this above mentioned anomaly. It however appears to be due to shallow metal distribution rather than an object such as a UST.

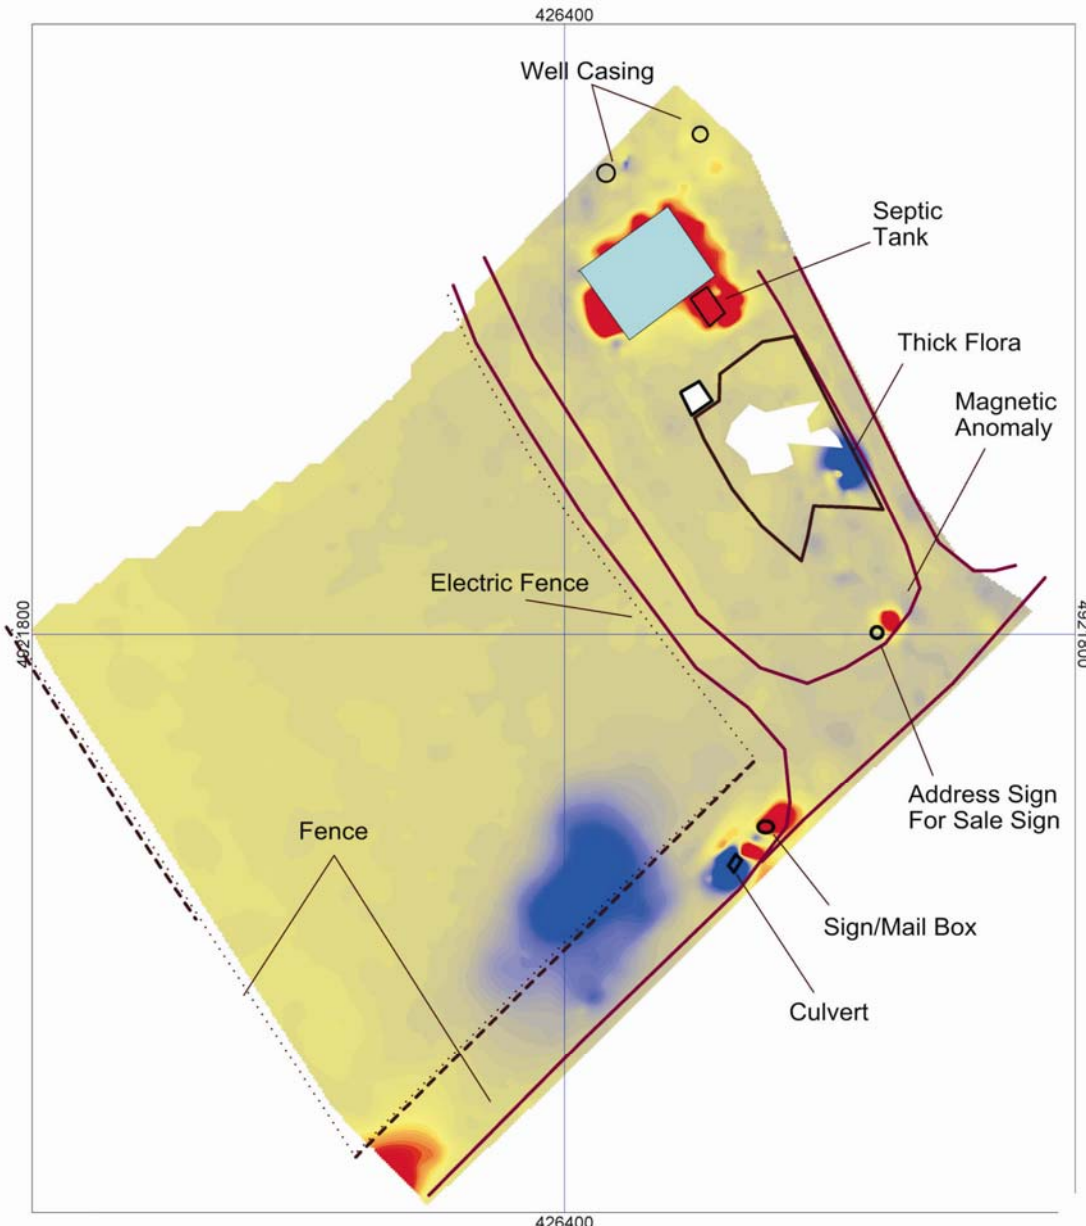
EM In-Phase
1376 County Rd. 2.
Escott, Ontario

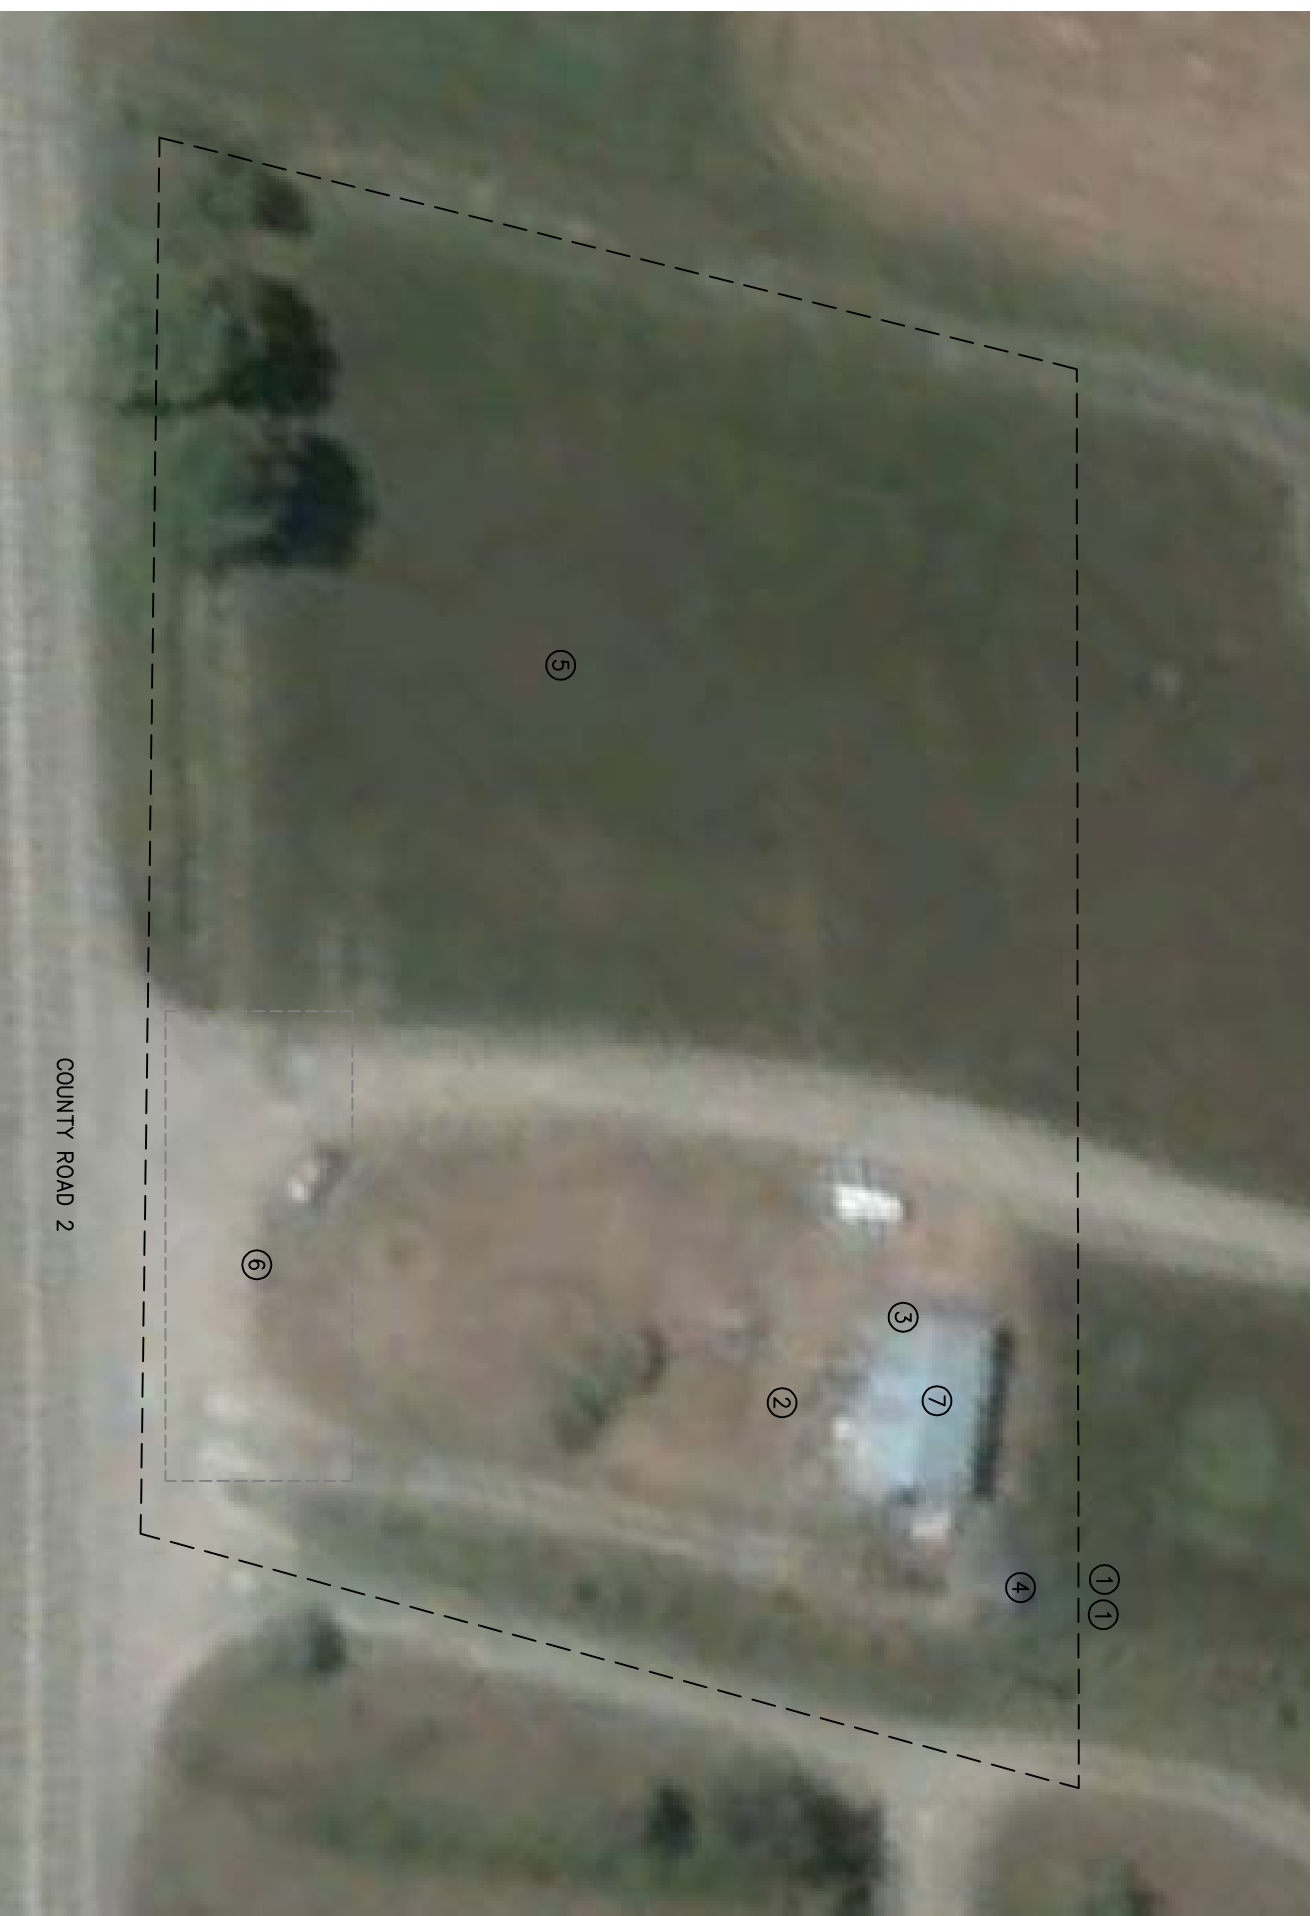
- ON-SITE DETAILS**
- ① DRILLED WELLS
 - ② SEPTIC SYSTEM
 - ③ ABOVE GROUND OIL TANK
 - ④ WOODEN SHED

- ⑤ PASTURE
- ⑥ FORMER GAS STATION/STORE
- ⑦ HOUSE
