## Director's Order

1-230768005

One hour Martinizing Dry Cleaning  
322 PINNACLE ST, BELLEVILLE, ON, K8N 3B4

PROJECT NAME			PHASE II ENVIRONMENTAL SITE ASSESSMENT		
CLIENT NAME			MARGARET MILLINGTON		
PROJECT LOCATION			322 PINNACLE STREET, BELLEVILLE, ONTARIO		
FIGURE NAME		BOREHOLE AND MONITORING WELL LOCATION PLAN		FIGURE NO.	
APPROXIMATE SCALE		PROJECT NO.	DATE	2	
AS SHOWN		119034	NOVEMBER 2016

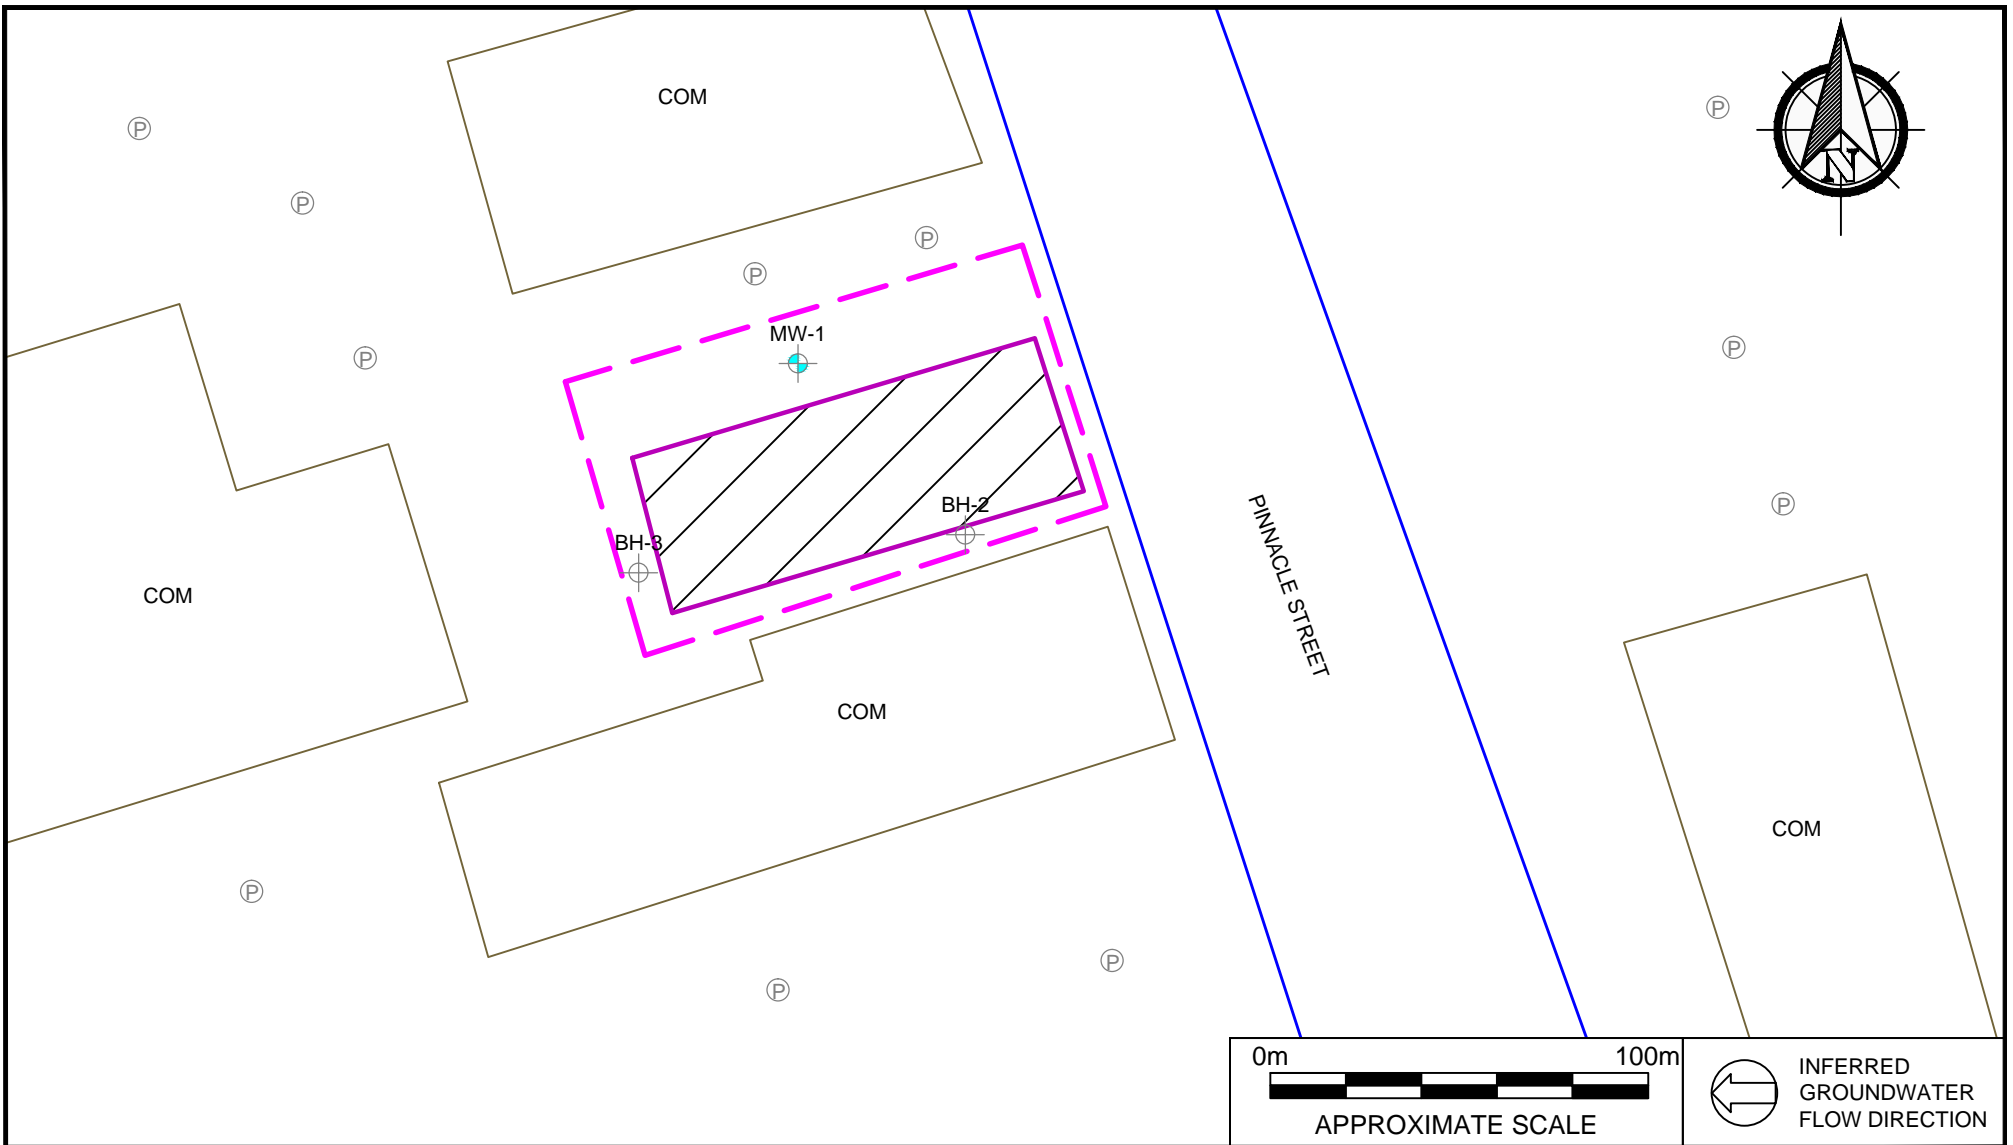
The findings of this Phase II ESA identified VOC-impacted soil and groundwater at borehole BH-3. As such, it is Pinchin's recommendation that a remedial excavation and dewatering program be completed in the vicinity of this borehole to remove the soil and groundwater exceeding the *Table 7 Standards*.

VOC-like odours and staining were observed in the soil sample SS-2 collected from borehole BH-3 at a depth of 0.6 to 1.4 mbgs; and, VOC-like odours and evidence of NAPL were observed during groundwater at borehole BH-3 during drilling. Groundwater and/or NAPL were not observed in MW-1 or BH-2.

The findings of this Phase II ESA identified VOC-impacted soil and groundwater at borehole BH-3. As such, it is Pinchin's recommendation that a remedial excavation and dewatering program be completed in the vicinity of this borehole to remove the soil and groundwater exceeding the *Table 7 Standards*.
