Wildlife Corridor Protection and Enhancement Plan

2nd Edition, February 2022

ACTION PLAN NO. 5

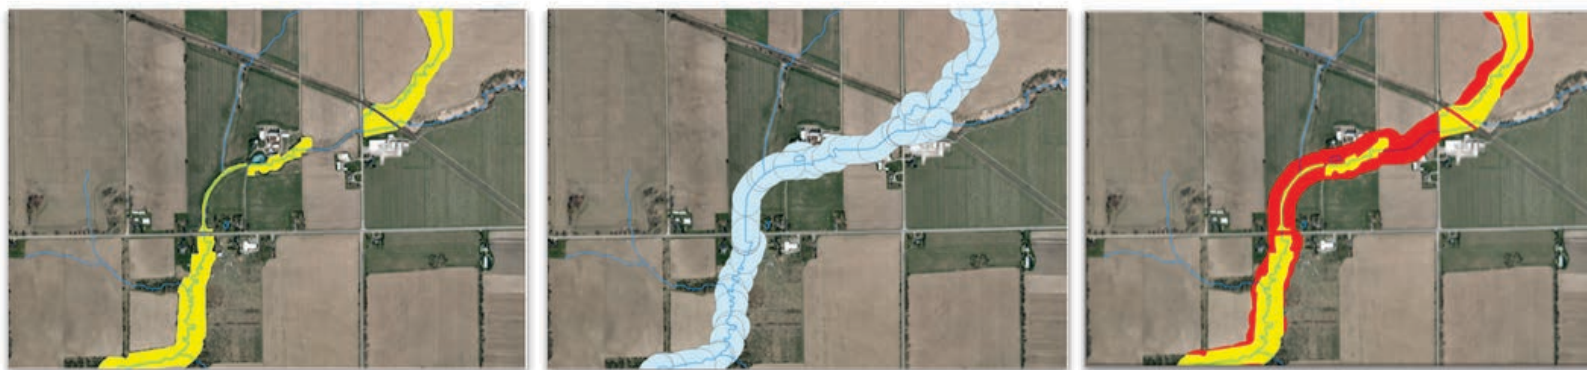
Corridors were originally delineated in 2015 following the method illustrated below. For this plan, the existing cover within the corridors was re-assessed using CLOCA's updated (year??) Ecological Land Classification (ELC) mapping and altered to reflect any changes in vegetation. 'Restored' corridors were also reviewed for this plan in consideration of changes in land use and any stream realignments or removals since 2015. Some corridors were altered or eliminated as a result of this review and these changes are discussed in later sections.

1. Map ELC within corridor to determine the 'existing' corridor.

2. Buffer the creek layer to the recommended width of the corridor (landscape = 100 m and local = 60 m) and refine as needed to determine the 'restored' corridor.

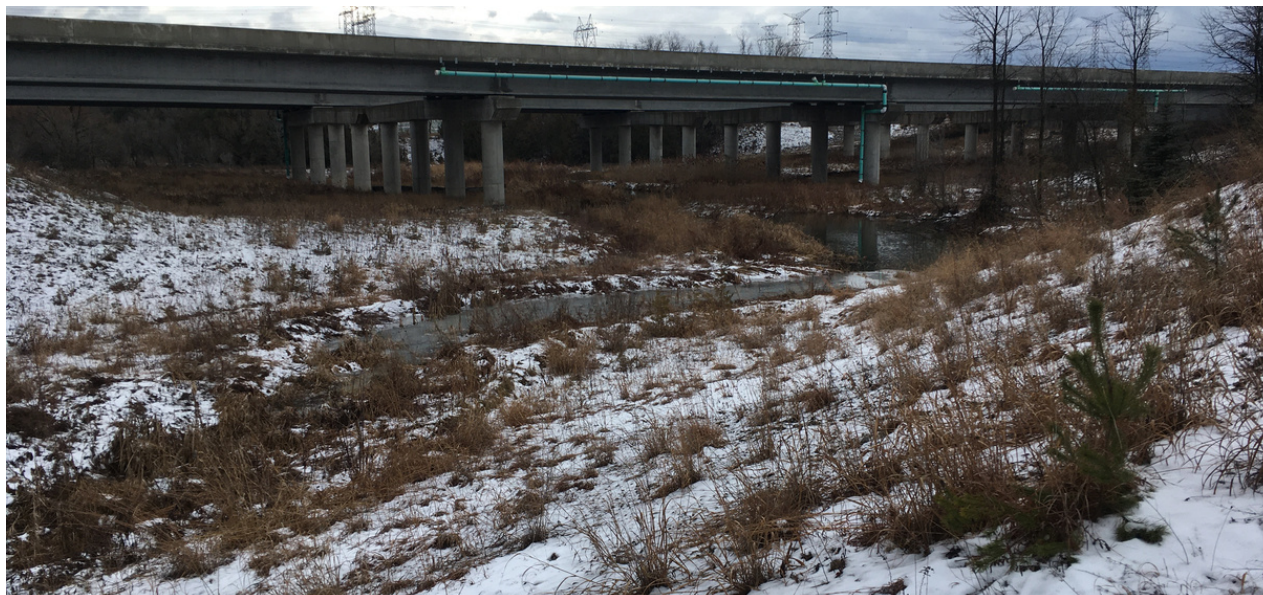
Highway 407 span bridge, Oshawa Creek, Oshawa, ON

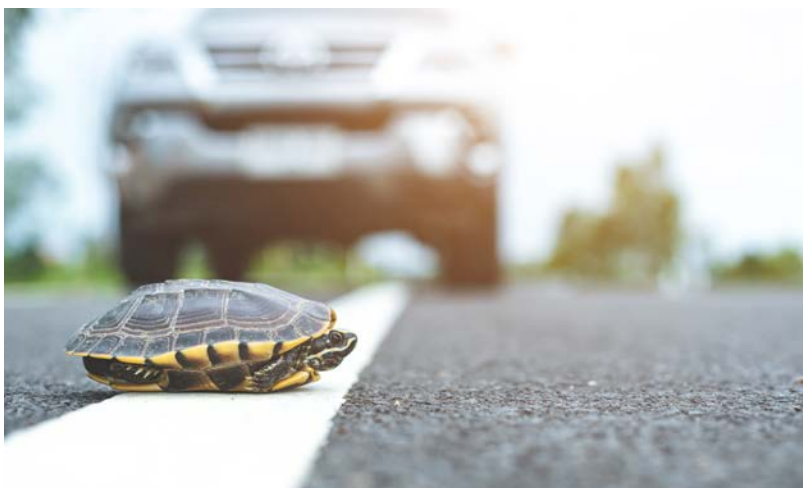
Figure 2: Lynde Creek wildlife habitat network, corridor gaps and infrastructure barriers

Figure 2, which presents the wildlife habitat network for the Lynde Creek watershed, also illustrates existing gaps in vegetation within the landscape and local corridor systems. These gaps appear in red, and they represent potential areas where movement may be impeded for wildlife requiring natural cover. Currently, the landscape corridors in the watershed are relatively well vegetated, with total natural cover in the system exceeding the watershed goal of 75 per cent. The local corridor system has a total of 56 per cent natural cover, so some naturalization or restoration efforts are required. Natural cover in the Lake Ontario Shoreline regional corridor is currently 64 per cent, just under the watershed plan goal of 67 per cent (Table 5).

The culverts and bridges that intersect with the wildlife habitat network in the watershed were reviewed and updated for this plan, and the new passage assessment system (Table 2) was applied. The location of existing passages and the structure class of each is shown in Figure 2 and the results are summarized in Table 7.

Concerted restoration effort in these locations would remove key gaps in the landscape corridor system. No priority restoration sites were previously identified within the local corridor system, but it is clear from Figure 2 and from the cover analysis in Table 5, focused restoration efforts are needed here, particularly within the Kinsale subwatershed.

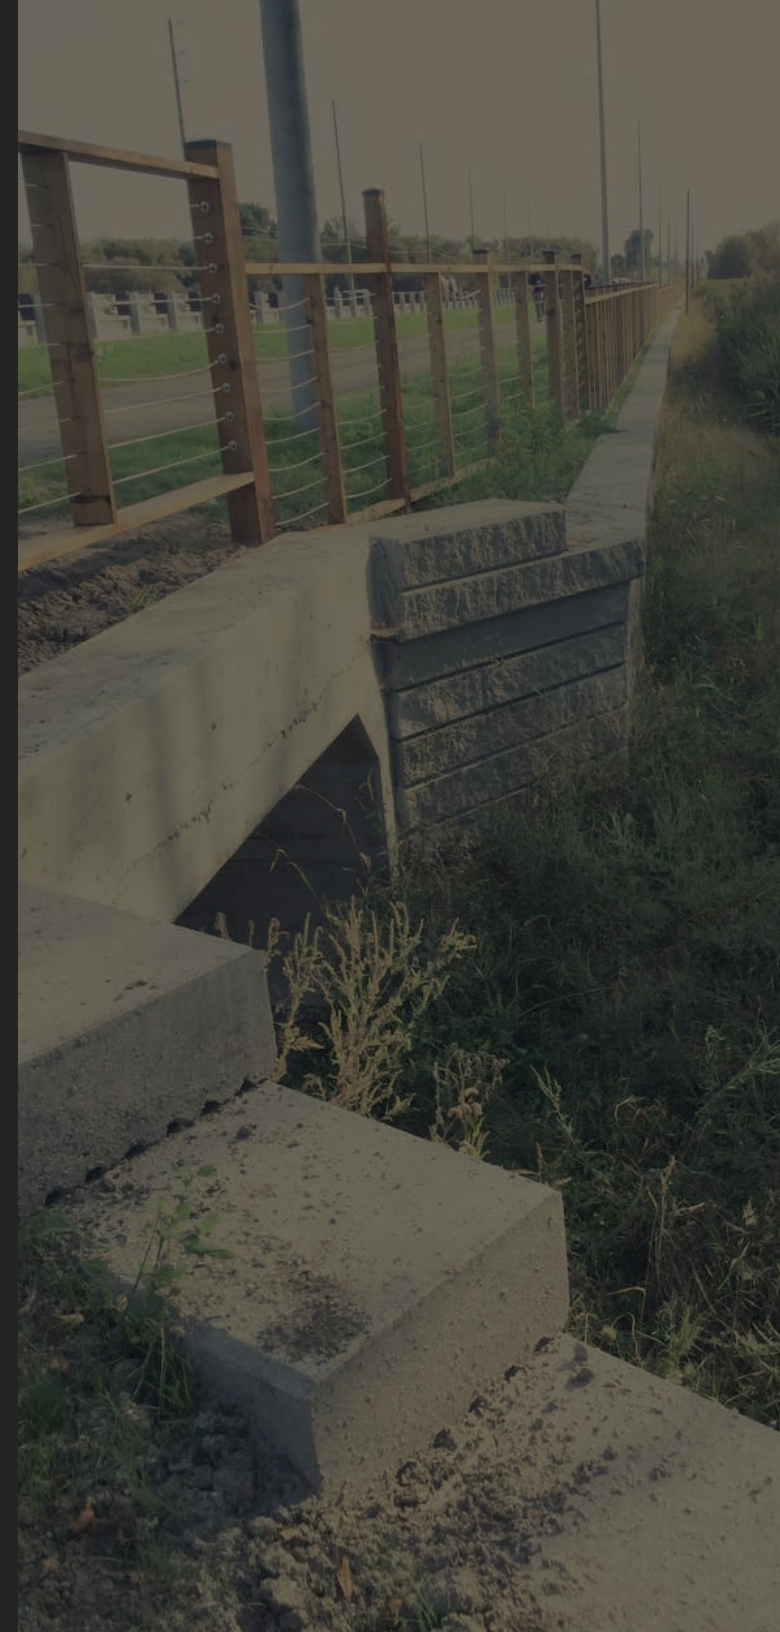
Partners in success. Working with Durham Region and their project consultants, CLOCA helped develop a road design that would meet the Region's transportation needs while also benefitting wildlife. Bridge structures were widened to include dry passages, a dedicated wildlife passage was incorporated, and four-foot exclusionary fencing was installed to prevent wildlife from accessing the road and directing them to the passages. Within the Marsh itself, the road was elevated and set atop a one-metre-high exclusion wall, which replaced traditional fencing. This elevated causeway, the only example of its kind built for wildlife in Ontario, demonstrates the value of partnership and the Region's environmental commitment.

Exclusionary wall to terrestrial passage.

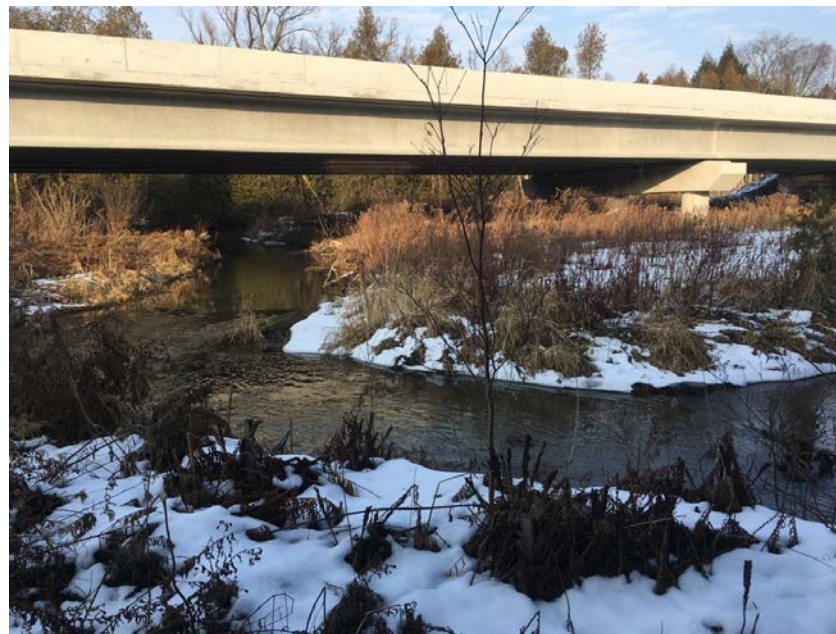
Highway 407 Class A example.

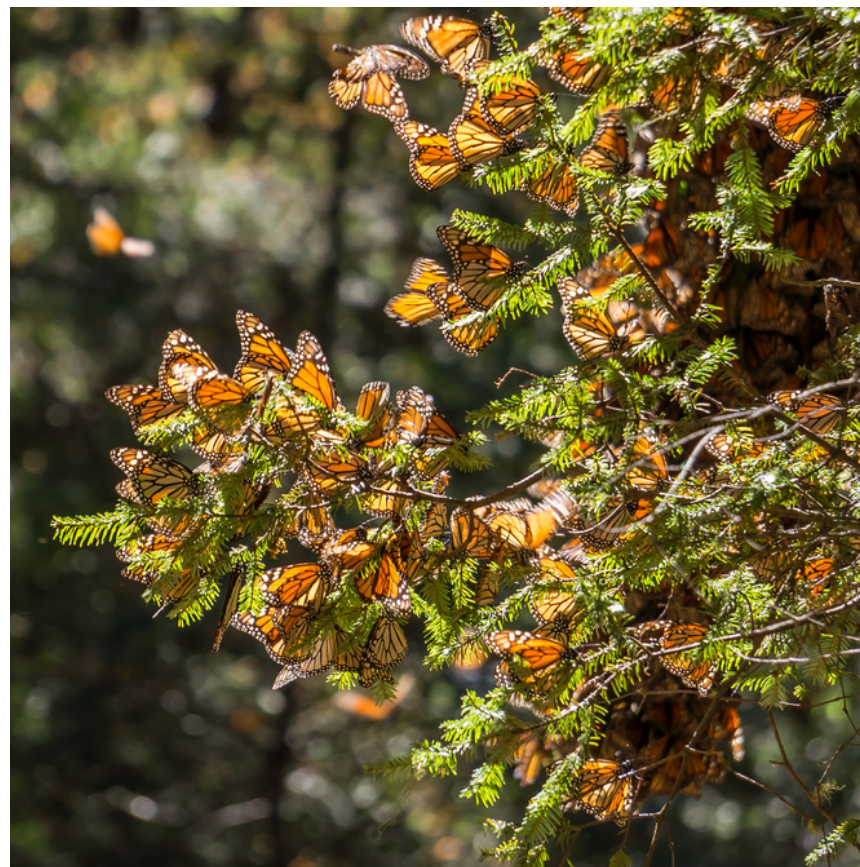
Figure 5: Bowmanville-Soper Creek wildlife habitat network, corridor gaps and infrastructure barriers

Figure 5, which shows the existing cover within the landscape corridors in yellow, the local corridors in orange, and corridor areas without natural vegetation in red, suggests that cover is generally well distributed, though there are some clear gaps, particularly in

Figure 5 shows the location of the breaks in the wildlife habitat network as a result of roads and rail lines. Any culverts and bridges that may act as passages beneath them were reviewed and updated to include new passages. The new passage assessment system (Table 2) was applied and the results are summarized in Table 16 below.

In 2015, 24 per cent (22 of 92) of the passages in the landscape corridor system and core habitats were evaluated as meeting the plan goal of Very Good or Better. An analysis of the 2020 passages using the 2015 assessment method suggests that 33 per cent (33 of 100) would have met that goal, indicating an overall improvement in wildlife movement potential within the landscape corridors and core habitats in the watershed. By comparison, 30 per cent (30 of 100) of these passages meet the new goal of being in structure classes A/A* or B/B* using the new assessment method. This improvement directly reflects the installation of highly functional span bridges along the Highway 407 route.

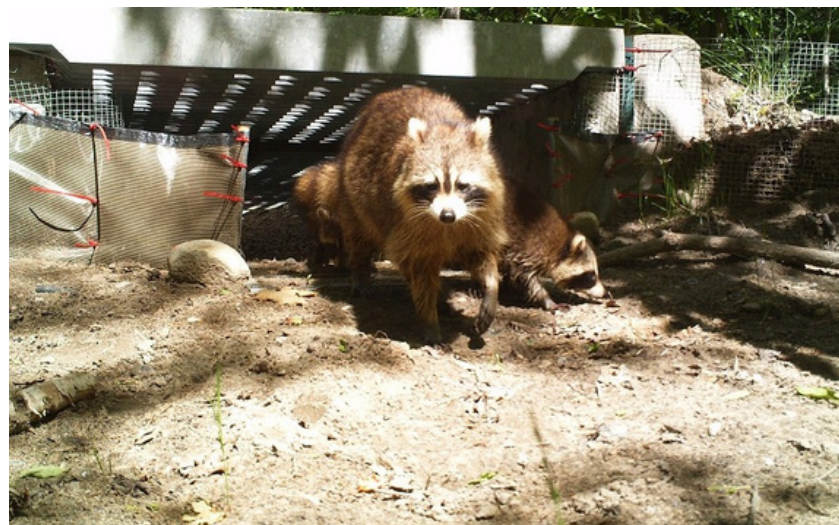
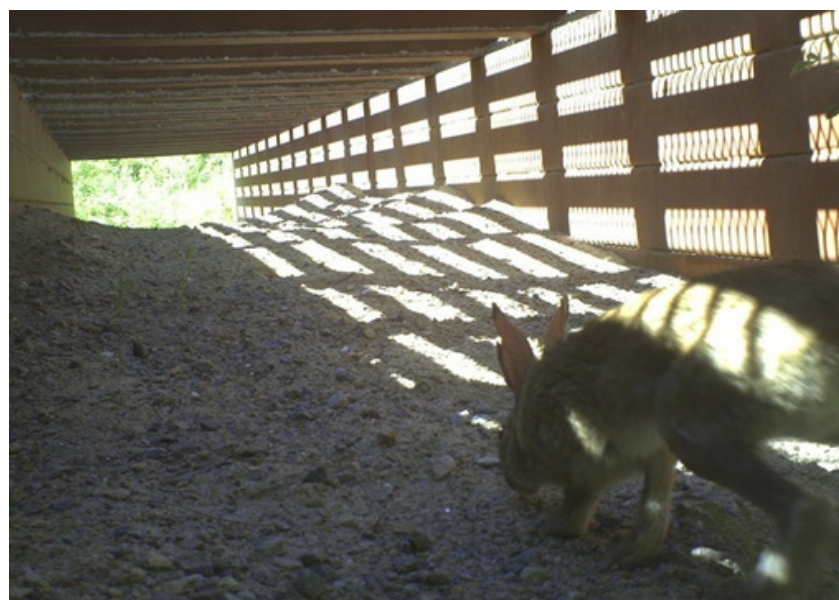
Figure 6: Small watersheds (west) wildlife habitat network, corridor gaps and infrastructure barriers

The culverts and bridges within the wildlife habitat network in the small watersheds were reviewed and updated, and the new passage assessment system (Table 2) was applied. The location of the passages and the structure class of each is presented in Figure 6 and Figure 7, and the results are summarized in Table 19 below.

Only six of the small watersheds have landscape corridors identified within the wildlife habitat network (Figure 6 and Figure 7), and the per cent natural cover within them ranges from nine per cent (Warbler and Cranberry Creeks) to 65 per cent (Pringle Creek). If the natural cover goal from the other watersheds is adopted (75 per cent), then none of the landscape corridors in the small watersheds meets that goal. Similarly, only three of the small watersheds have local corridors identified in them and if the 75 per cent corridor cover goal is also applied, then all of the corridors fall short of meeting the goal. The watershed closest to the 75 per cent goal is Darlington Creek.

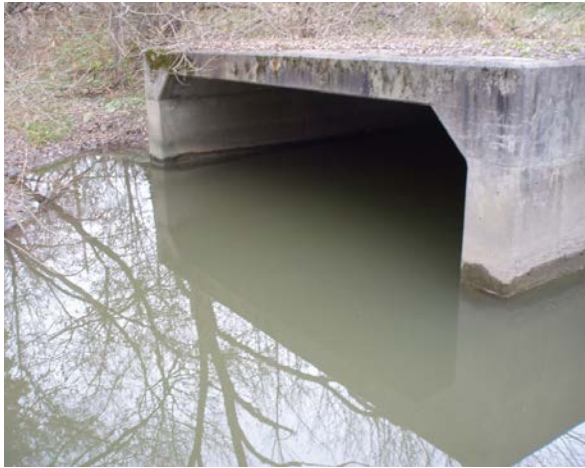
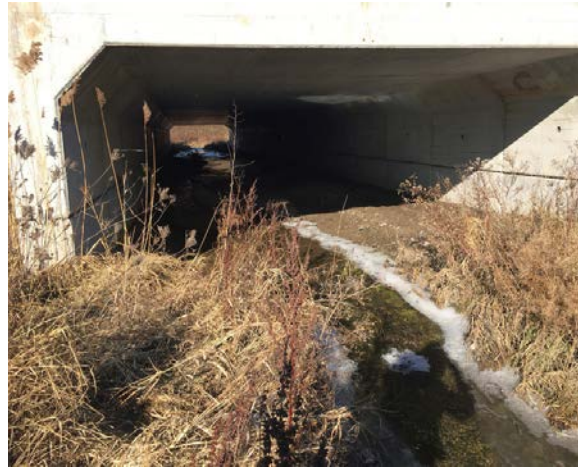
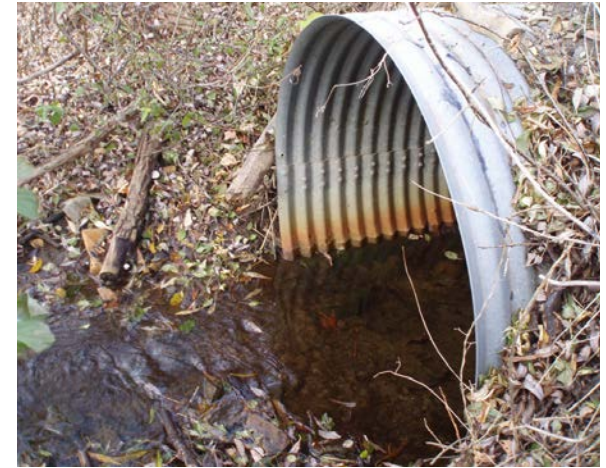
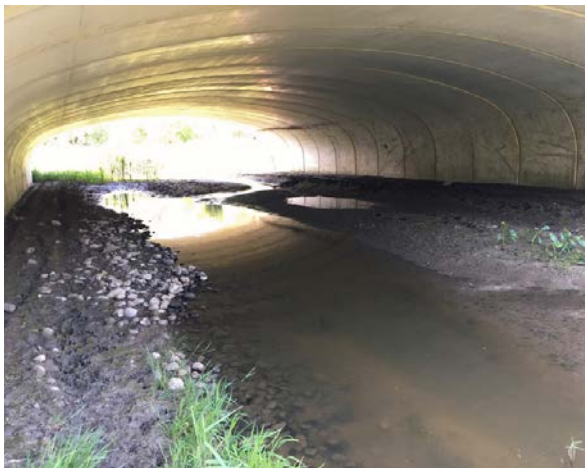
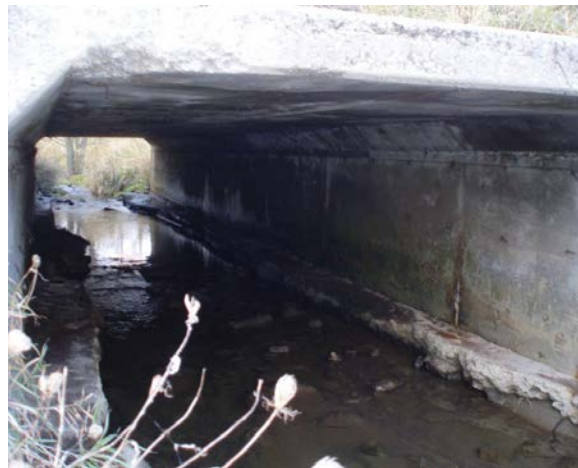
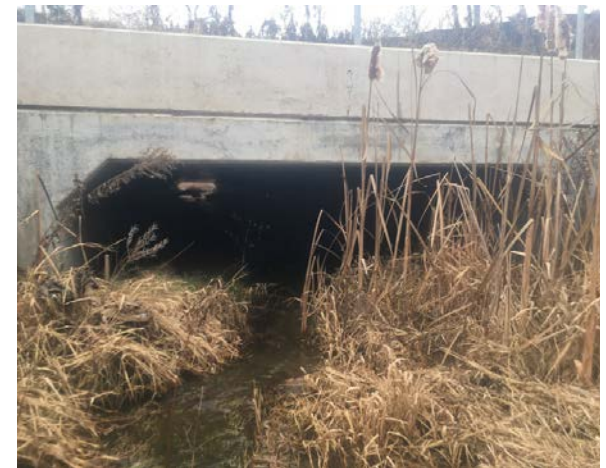
Before-and-After examples

These photos are examples of upgraded culverts in the Lynde Creek watershed. The top row shows what the passages looked like in 2015 and the bottom row shows how they look today. Previously, they all suffered from a lack of dry passage. As the 'after' photos show, these passages are now passable for both aquatic and terrestrial wildlife.
