Ministry of Mines  
Category C Environmental Assessment  
Project Documentation  
Long Lake Gold Mine Rehabilitation Project

Mine Rehabilitation Section  
Mines and Minerals Division

**Last Revised:** December 6, 2023

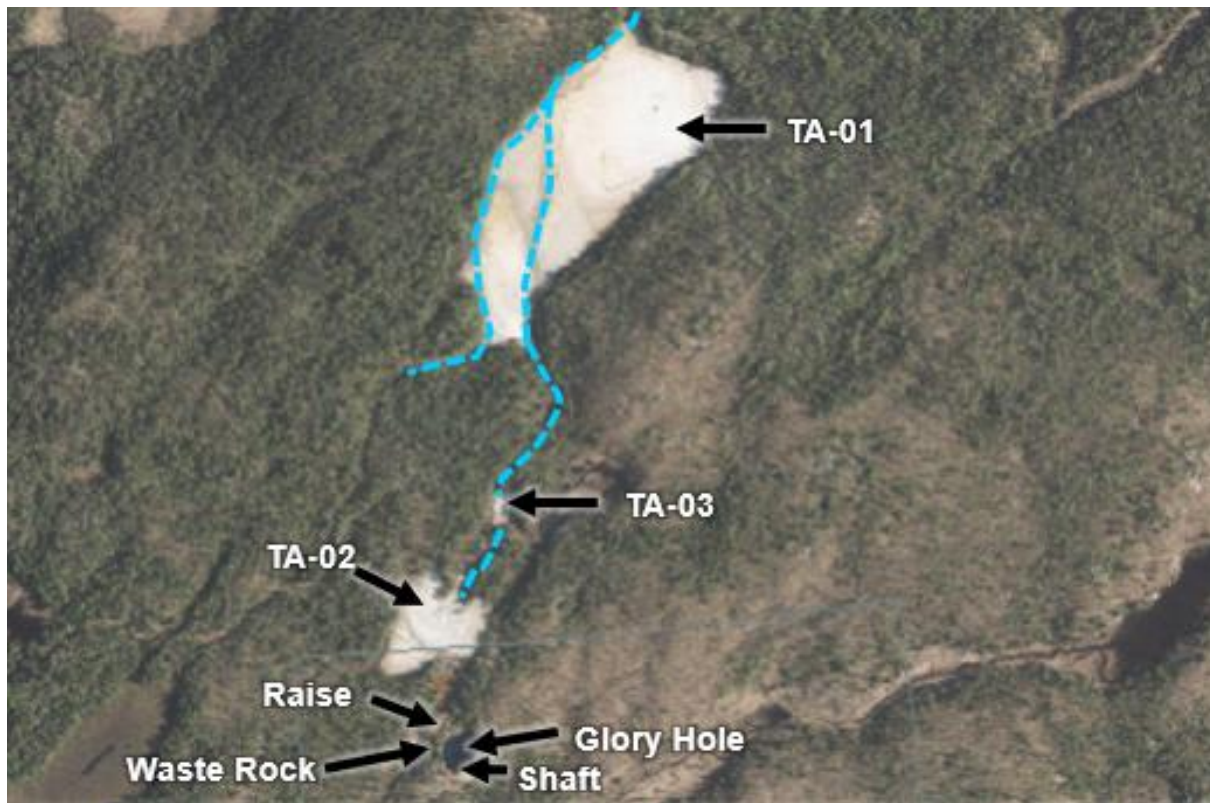
**Figure 2** - Site plan illustrating the mine features and surface water drainage channel. Image Source; NHIC Map 2022.

A site characterization study completed by CH2M Hill in 2013 has found that the tailings contain sulphide minerals including arsenopyrite and pyrite. Arsenopyrite and pyrite are sources of acidity and arsenic. Surface runoff and seepage from the tailings are characterized as potentially acid generating (PAG) and contain elevated metal concentrations, especially with respect to arsenic (CH2M Hill 2013). Surface runoff from the tailings' discharges directly into Luke Creek, which flows into the south bay of Long Lake and then to Round Lake located on AAFN reserve lands. Over time, the tailings have eroded into the receiving environment resulting in the deposition of tailings into Luke Creek and the south bay of Long Lake. A tailings "delta" has formed in Long Lake at the outlet of Luke Creek. A site plan illustrating the mine features and tailings delta is provided below on Figure 2.

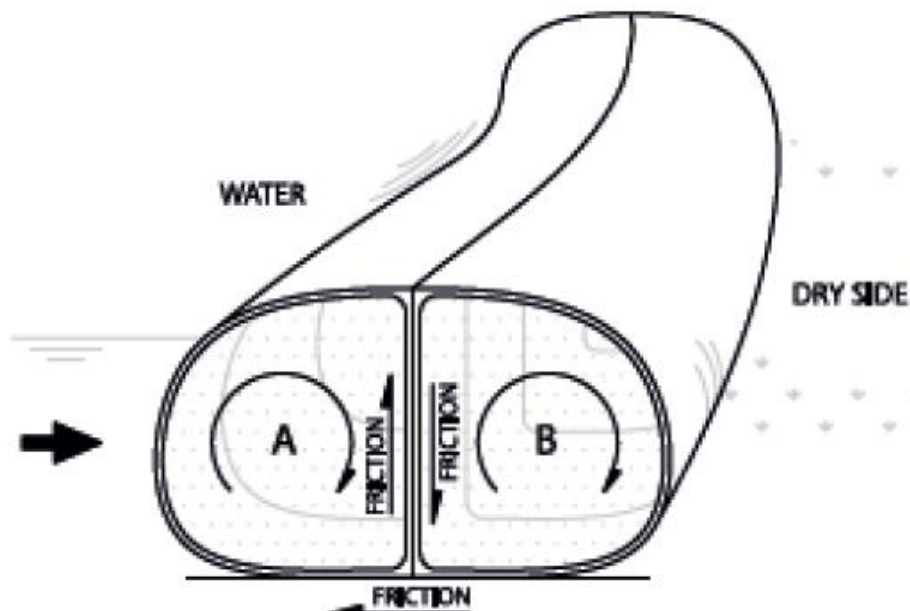
**Figure 3** - Cross section of a typical AquaDam water barrier. The structure consists of two polyethylene 'inner tubes' filled with water encased by a stronger but flexible 'outer tube' made of a woven geotextile. Image source: Layfield

Removal of fugitive tailings and contaminated material from within Long Lake will be completed in a similar manner as what is described above for the drainage channel and Luke Creek. The delta will be isolated in sections over three excavation phases using an AquaDam. An AquaDam is a stable portable water barrier that is used to contain, divert, and control the flow of water, as illustrate in Figure 3 below. For each phase, water will be removed from that section and the material excavated using a long reach tracked excavator. Backfill will be placed in the excavation area and rounded cobble along the shoreline. It is assumed that wind and waves will allow surrounding lake sediment to naturally fill rehabilitated areas. The work will be completed outside of the restricted timing window for fish protection, to protect fish and aquatic species from potential impacts during spawning, migration, and other critical life stages.

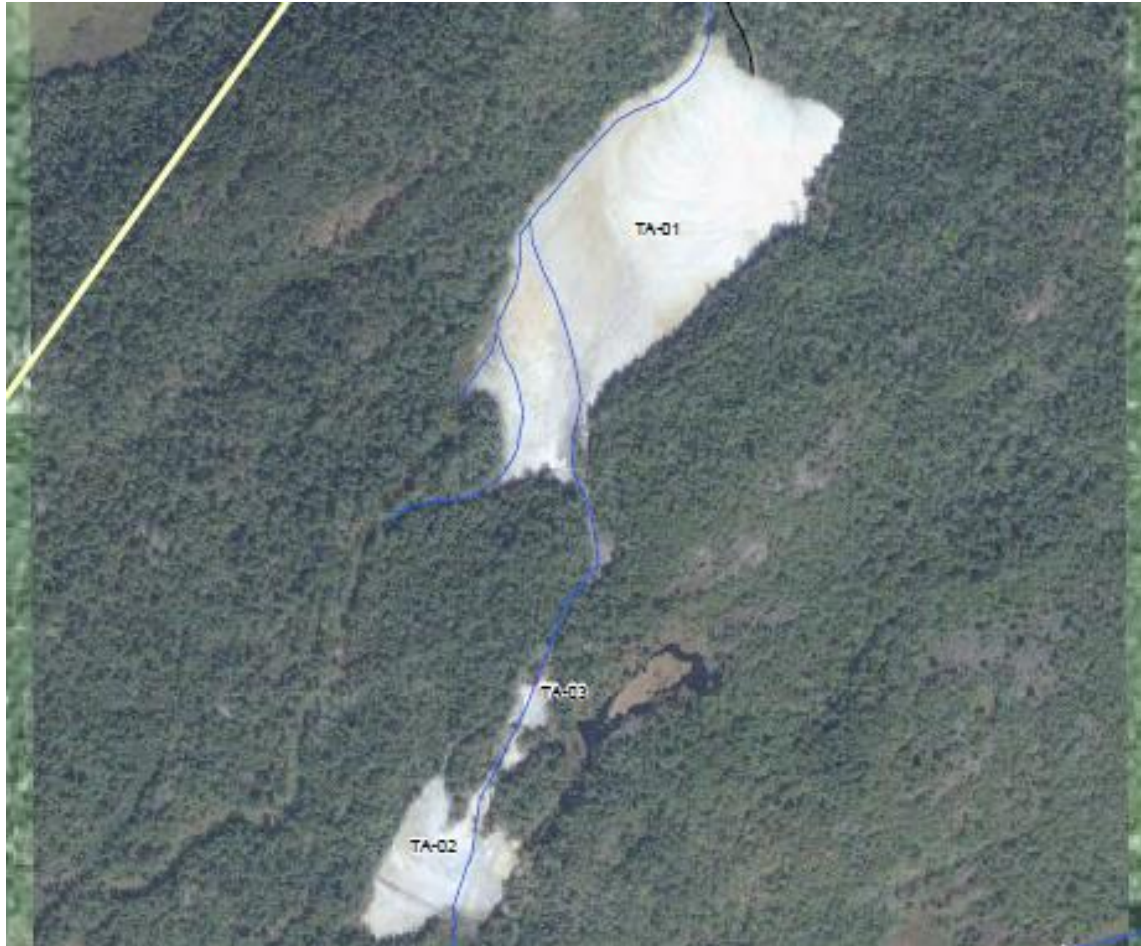
**Figure 6** – Location of three tailings areas and interconnecting drainage channel (Image Source: CH2MHill 2013)

The three tailings' areas (TA-01, TA-02 and TA-03) are situated in low-lying areas that naturally contain the material within the surrounding topography. The tailings are interconnected by a surface water drainage channel, which flows in a northerly direction towards Luke Creek and eventually empties into Long Lake. The location of the tailings areas and drainage channel is illustrated below on Figure 6.

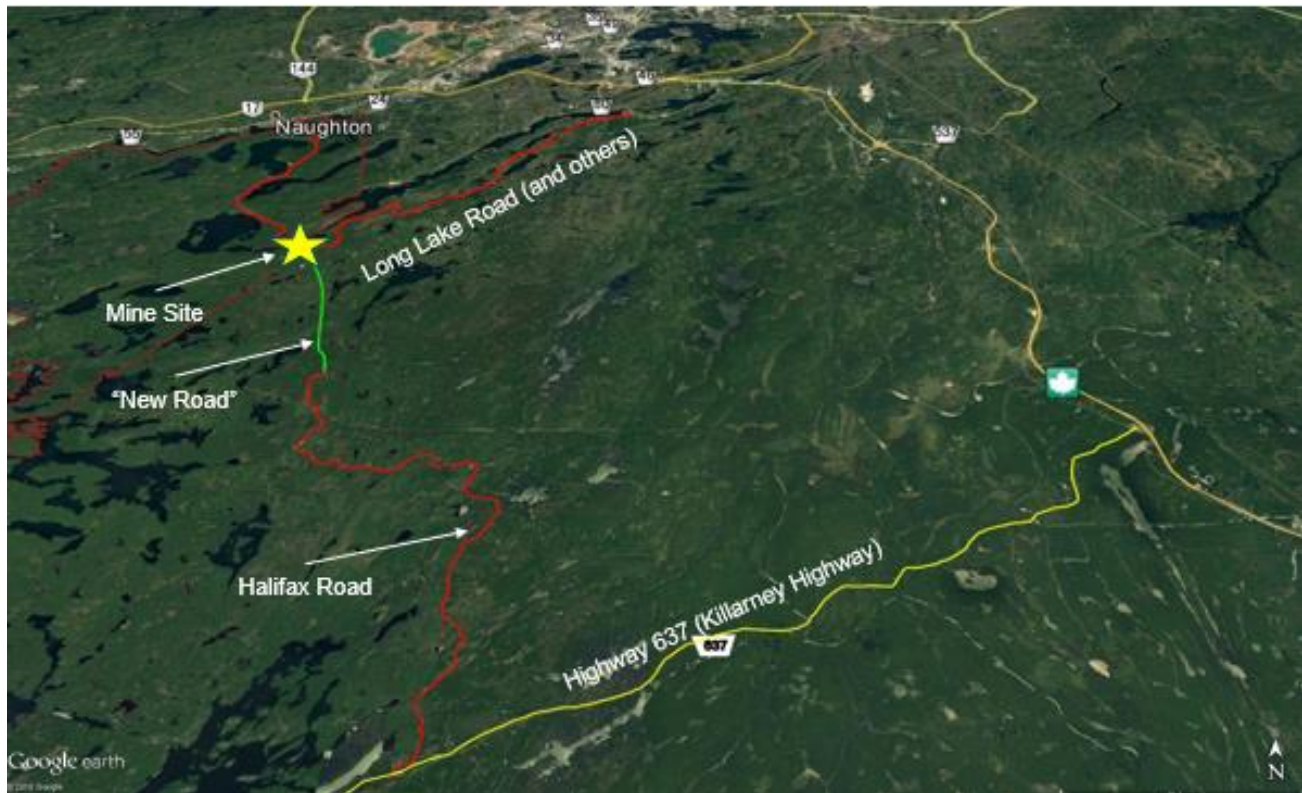
**Figure 7** – Location of the Halifax Road extension alternative.

This alternative involves the construction of a new 8.6 km road extension from the end of Halifax Road, located off Highway 637. The location of the existing road and proposed extension is illustrated below on Figure 7.
